**Inquest into the deaths of Kate Goodchild,  
Luke Dorsett, Cindy Low & Roozbeh  
Araghi at Dreamworld, October 2016**

**Findings and Recommendations  
February 2020**

### FINDINGS OF INQUEST

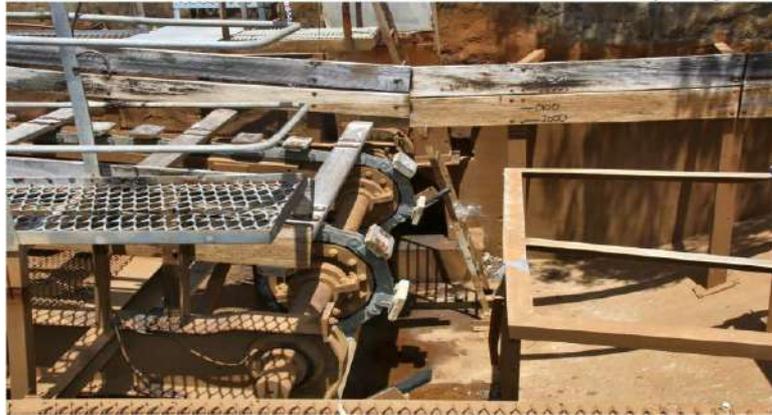
interface between the conveyor's long planks at their furthest point, and the leading edge of the support rail was found to be 430 mm, with a 760 mm gap between the leading edge of the support rails and the drive axle (when exposed).<sup>82</sup>

DEPICTS SIDE PROFILE OF INTERFACE, Ex. B2, pg. 21

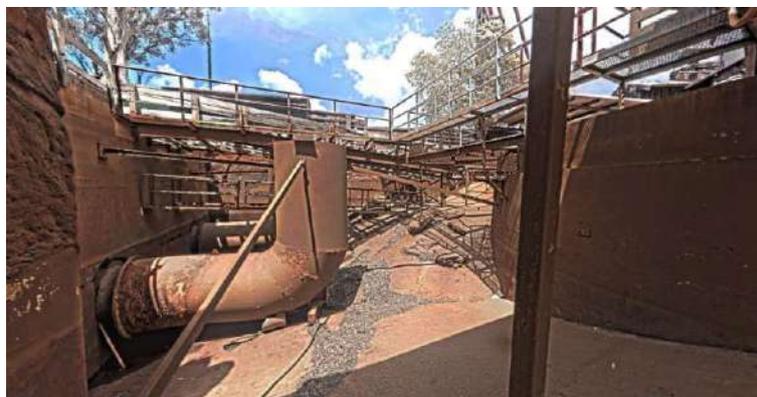
**PUMP OUTLETS IN PIT, EX. B2, PG. 15**

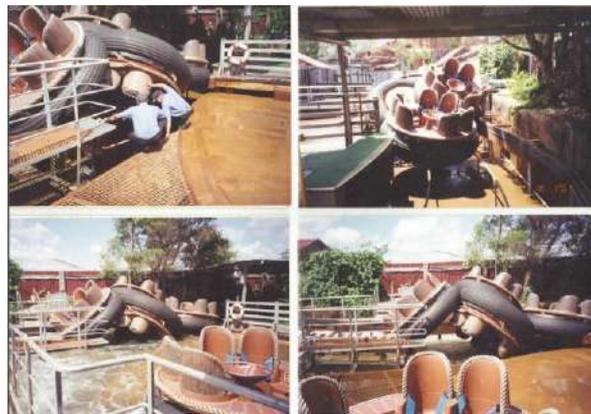
218. On 18<sup>th</sup> January 2001, Ms. Melinda Lynd was rostered to perform the role of No. 1 Ride Operator on the TRRR. She commenced the start-up procedure at approximately 9:17 am, releasing all of the rafts to run a full cycle, prior to opening the ride to guests.<sup>323</sup> She was the only Operator present at the time. At around 9:30 am, Mr. Joe Stenning, who was rostered on as the No. 2 Operator for the TRRR that day, arrived and opened the queue line for guests. Whilst the empty rafts were travelling the water course, guests had commenced lining up. As Ms. Lynd began speaking to guests in line, two rafts became stationary at the unload area, with a further three traveling down the conveyor, having completed a full cycle of the ride.<sup>324</sup> This was noticed by both Ms. Lynd and Mr. Stenning, however, no attempt was made by Ms. Lynd to release the stranded rafts. As the three additional rafts came off the conveyor, they collided with the stationary rafts, causing one to flip. Having seen the rafts flip, an operational Code 6 was called, at which time Ms. Lynd called 222 and tried to describe the incident, which was not clear. She then hit the emergency jack button and stopped the conveyor.<sup>325</sup> The rafts were unable to be freed. Senior Attractions staff arrived at the TRRR shortly thereafter, and guests were cleared from the area. The following photographs of the aftermath of the incident depict the scene.

**2001 INCIDENT - Ex. B10(1)**

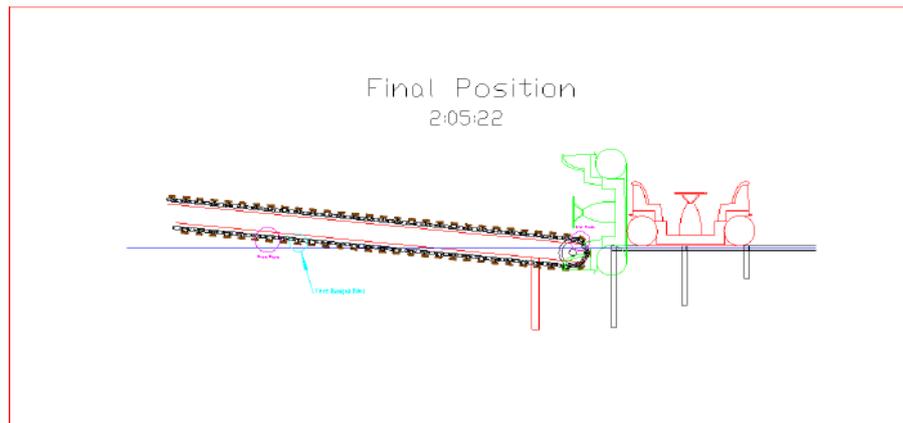
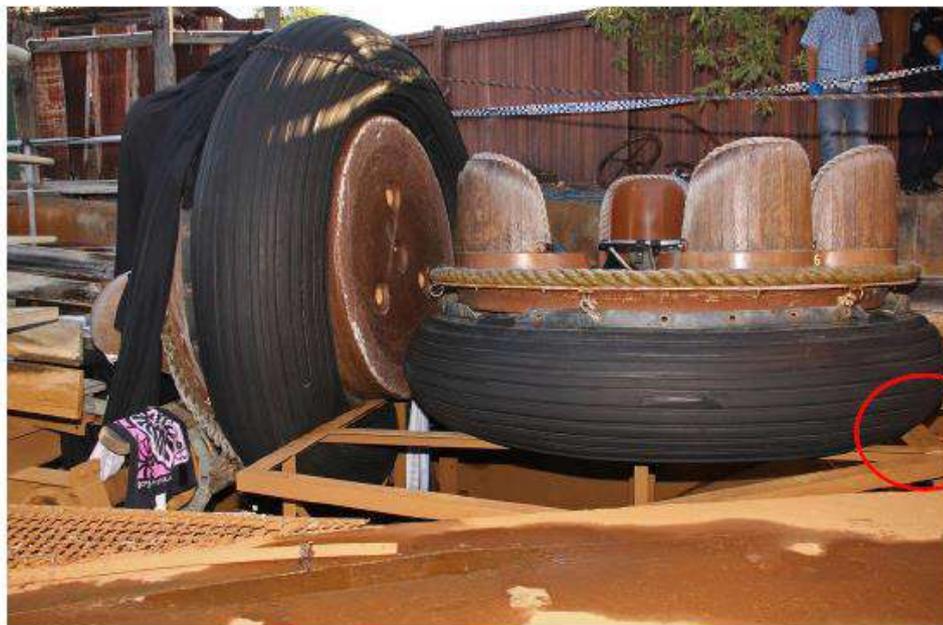
**FINAL RESTING POSITION OF RAFT 5 & RAFT 6 - Ex B2, pg. 51**

471. It is evident that it only took one minute and 17 seconds from the time the south pump failed until Raft 5 became inverted.<sup>885</sup>
472. Investigators have established that within the first 15 seconds of a pump failure on the TRRR, approximately (200mm) of water height was drained.<sup>886</sup> As Raft 6 entered the unload area, there was insufficient water flow for it to proceed forward over the support rails once it exited the conveyor. This occurred within 20 seconds of the pump failure.<sup>887</sup>
473. Further testing conducted by Investigators following the incident confirmed that when one pump was not operational there was a difference in water level of

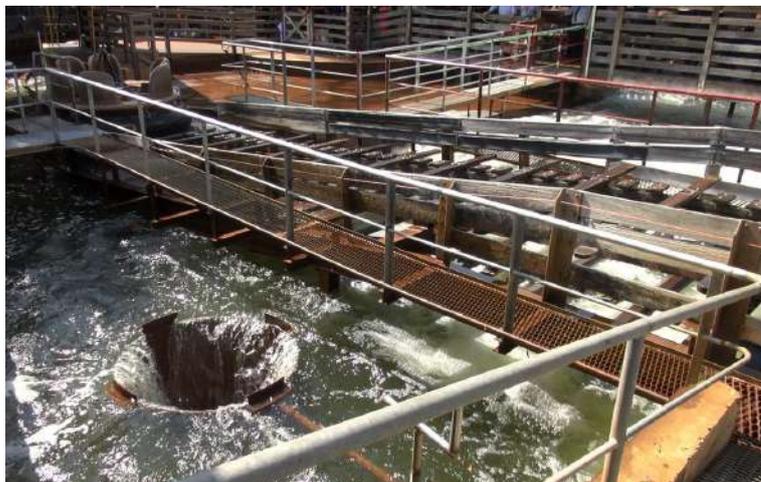
478. Testing also revealed that the opening of the pump outlets within the pit area under the conveyor were at a level lower than that of the raft support rails.<sup>893</sup> Due to this design aspect of the ride, and the large volume of water that is extracted during the reverse flow, the water drops below the level of the rails quickly.<sup>894</sup>

**DEPICTS NORTH PUMP OPERATING WITH BACKFLOW & EXPOSED RAILS**  
**- Ex. B2, pg. 87**

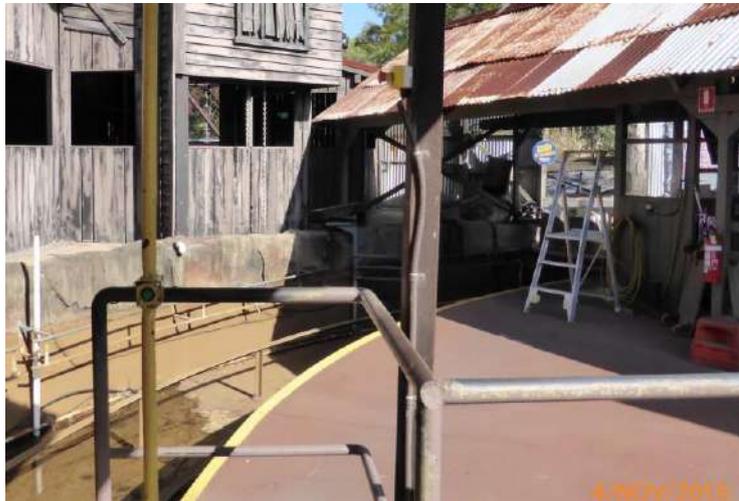
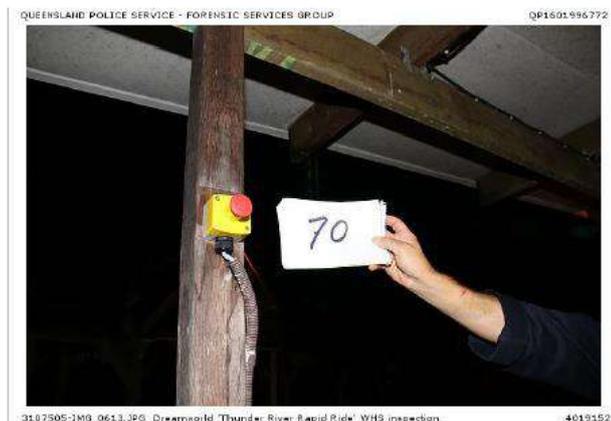
558. The E-Stop at the unload area at the time of the tragic incident, appeared as below:<sup>1151</sup>

559. Despite the recommendations made by the external auditor that the ride control buttons, including the E-Stop, should be labelled and the action identified, in a response provided to OIR by Ardent during the course of their investigation into the circumstances of this tragic incident, they maintain that *'the emergency stop button at the unload platform of the TRRR was clearly marked on 25 October 2016'*.<sup>1152</sup> This is clearly not the case.
