**Inquest into the deaths of Kate Goodchild,  
Luke Dorsett, Cindy Low & Roozbeh  
Araghi at Dreamworld, October 2016**

**Findings and Recommendations  
February 2020**

### FINDINGS OF INQUEST

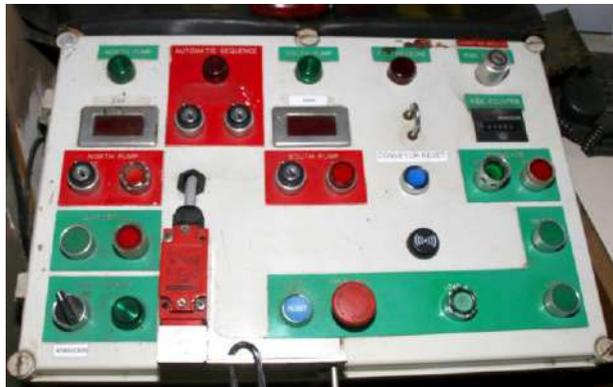
**MAIN CONTROL PANEL AS IT APPEARED OCT 2016 - EX B2, PG. 30**

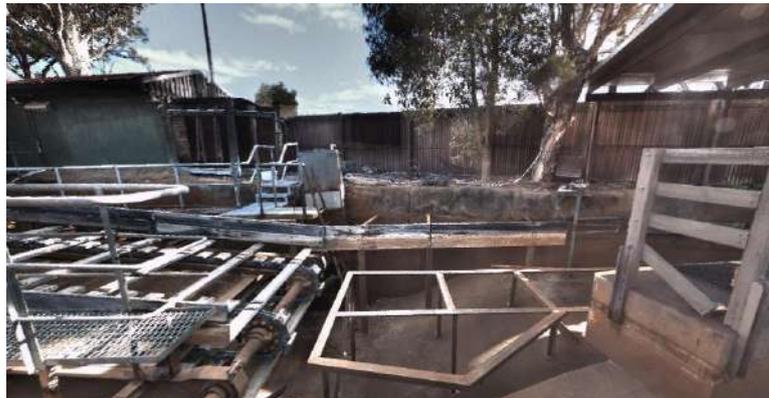
**EX B2, PG. 14**

66. Additionally, there were a series of support railings in the trough prior to the beginning of the conveyor (bottom), which were installed in 2015.<sup>68</sup>
67. In the area of the incident at the end of the conveyor (top), there was no variation in the level, with the support rails having been adapted to suit the sloping nature of the flooring leading back to the area beneath the conveyor, known as the 'pit'.<sup>69</sup> This area is where the water for the ride was gravity drained back into the storage reservoir.

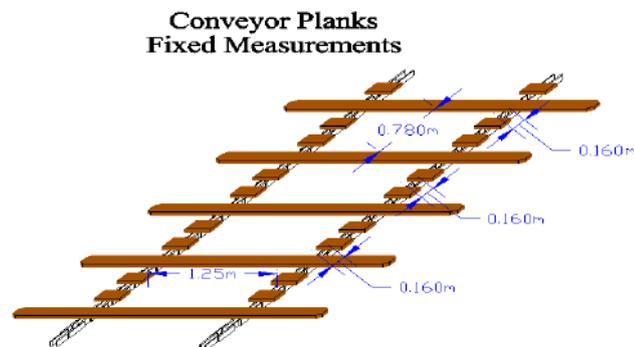
73. The measurements of the conveyor planks, including the spacing and configuration, are as follows:<sup>80</sup>

74. The speed of the conveyor was found to be 2.7 kph.<sup>81</sup>
75. An open air gap was found between the end of the conveyor closest to the unload station and the beginning of the raft supporting rails. This interface area, which was significant during the incident as it was into this gap that Raft 5 was pulled down once inverted, was extensively examined and measured. The gap of the

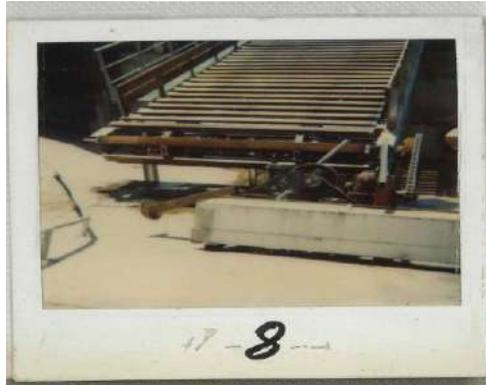
106. The below photograph depicts the conveyor as it was initially constructed in 1985.<sup>132</sup>

107. Mr. Wood stated during the inquest that by the time he left employment with Dreamworld in 2012, every 2<sup>nd</sup> and 3<sup>rd</sup> slat had been removed from the conveyor.<sup>133</sup>
108. According to Mr. Tan, who was employed in various roles within the Engineering Department, including as the Manager since 1987, the removal of the wooden slats on the conveyor took place between 1988 and 1990 because it was frequently tripping.<sup>134</sup> The boards were removed to reduce the weight the conveyor motors were required to drive, and to improve the chain 'release' from the head sprocket.<sup>135</sup>

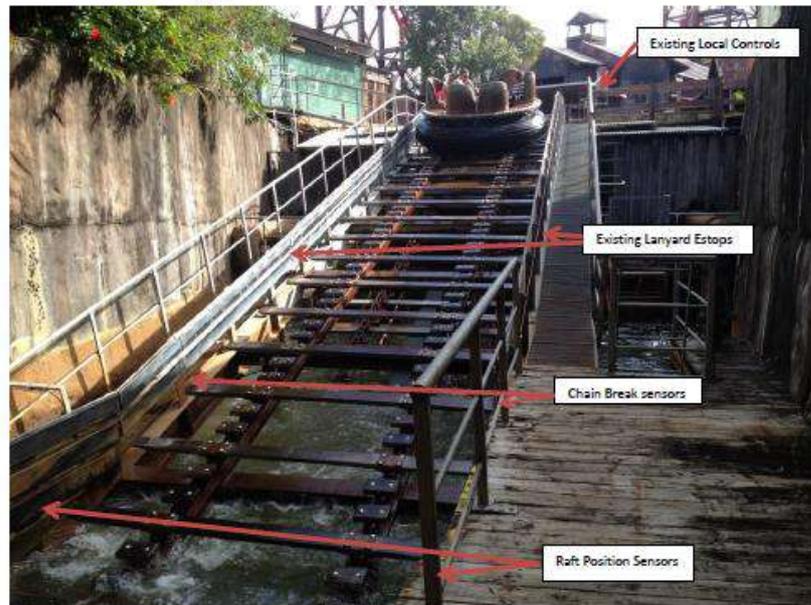
**TRRR CONVEYOR CONTROLS UPGRADE OVERVIEW - EX B12 (11), PG. 2**

131. It was also proposed that the scope of work be expanded to include an upgrade of the Main Control Panel, as it had been *'adapted and added to over many years and are in a poor state'*.<sup>172</sup> Mr. Ritchie clarified that he was referring to the organisation of the wiring on the Main Control Panel as it was difficult to follow and untidy.<sup>173</sup> The hardware was older and there was no colour coding, numbering, labelling or features that would be expected for new wiring that readily identifies the systems that each wire operates.<sup>174</sup> Furthermore, there were no 'as built' electrical drawings, as well as different electrical components that had different voltages in the same system.<sup>175</sup> Mr. Ritchie noted that these aspects made reviewing the electrical components of the Main Control Panel *'slow and time consuming'*.<sup>176</sup> He did not consider, however, that the state of the control panel adversely affected the safety or operation of the ride.<sup>177</sup>
